### Case history: Nitrolance at Brunner Island Power Plant, York Haven, Penn.

# Eliminate secondary waste stream utilizing pressurized liquid nitrogen

By Elizabeth Foley-Saxon

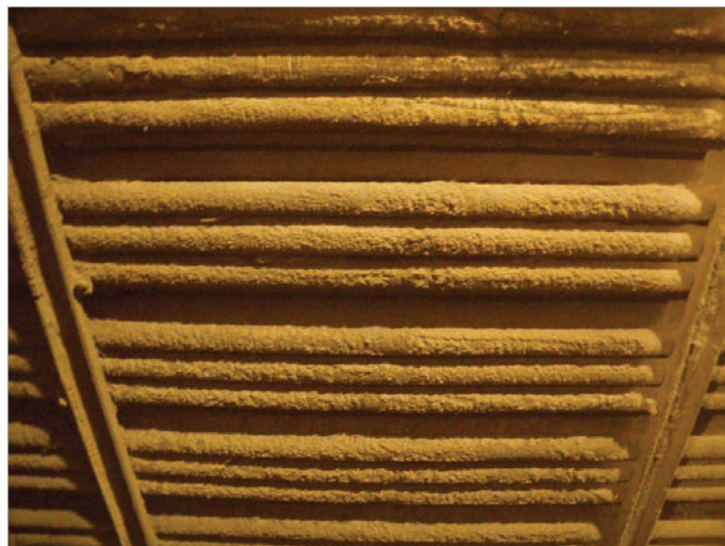
Figure 5. Fouled pre-heater coils.

Pennsylvania Power & Light's Brunner Island Unit 3 is a 760 MW coal-fired unit. The fouling in the Ljungstrom™ rotary regenerative air preheater was due to fly ash deposits, dust, debris and lube oil that had formed a thick shell over the fin coil surfaces. Since this unit is typically a base-loaded unit, it can only come down for maintenance at scheduled outages. Previous attempted cleanings of the air preheater used water, chemicals and detergents. These methods were ineffective in removing the tenacious fly ash and oil deposits. In operation, this fouling created restricted combustion air flow and led to a megawatt output reduction during certain weather and operating conditions. As an outage approached for the unit, the Nitrolance system was approved by PP&L engineers and the air preheater coils were scheduled for cleaning.

At the start of the unit's outage and the beginning of the Nitrolance cleaning, the system's delivery pressure was carefully adjusted to make sure that the heat exchangers' delicate tube fins (0.012" thick) were not damaged. Once cleaning commenced, the fly ash and other deposits were removed in seconds and a majority of the air preheater was cleaned in only 12 hours. See the fouled preheater coils in Figure 5 and a direct comparison of the fouled and results of the cleaned coils in Figure 6.

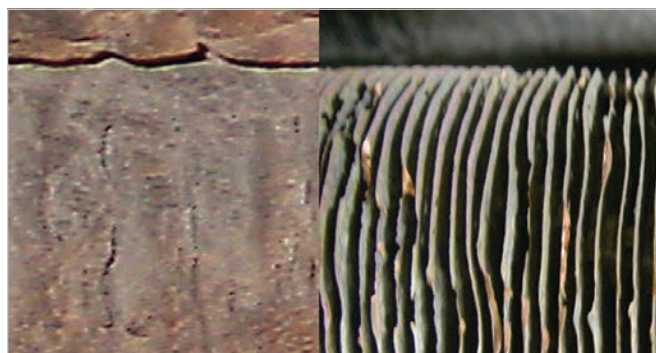
Figure 6. Fouled on the left and cleaned on the right.

After the unit was brought back in service, immediate results showed that the airflow blockage was significantly reduced. In addition, the air flow pressure drop across the air heater was reduced by half. Although still higher than the original design air flow pressure drop, the improvement was significant considering only a portion of the air heater was cleaned due to time limitations. The potential exists for additional improvements by returning to the unit and cleaning 100 percent of the tubes.

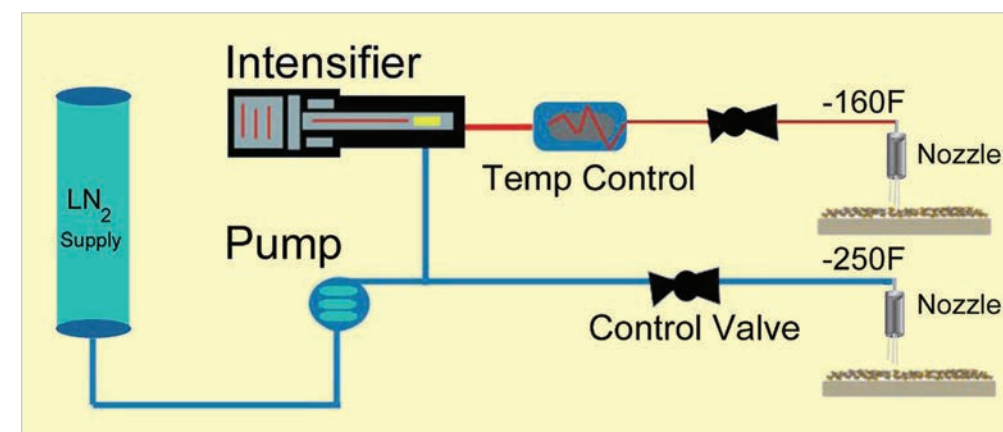
Figure 1. Nitrolance process flow.

Enter the Nitrolance cleaning system, which delivers pressurized liquid nitrogen to the cleaning surface of air heaters and rapidly removes deposits through three mechanisms of action: thermal expansion, mechanical pressure and super cooling. The thermal expansion action occurs as the high-density vapor penetrates the cracks and crevices of the fouling deposit. The rapid expansion of gas, combined with the delivered pressure and cold temperature, causes the fouling deposit to break apart and release its bond with the metal. The particulate deposit is then removed, as shown in Figure 2. Mechanical pressure is exerted from the nozzle tip of the Nitrolance as

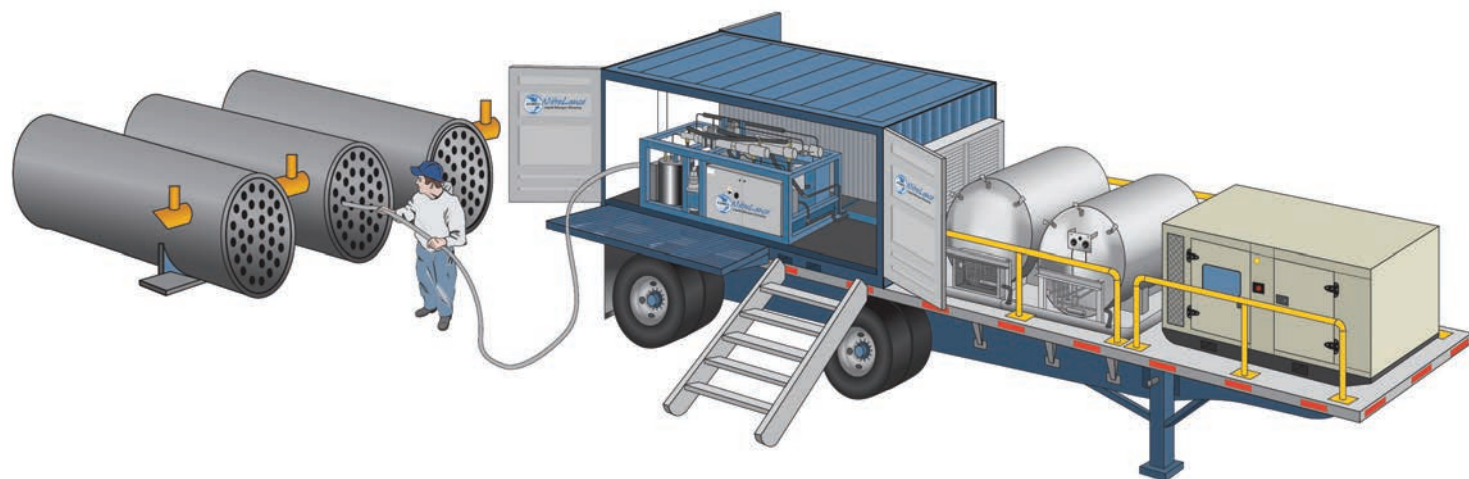
Figure 3. Mobile platform for Nitrolance.
